# BELLINGEN SHIRE COASTAL MANAGEMENT PROGRAM STAGE 2 SUMMARY REPORT

| <b>Authors:</b> | David Wainwright and Emma Graham<br>(Salients Pty Ltd) |
| <b>Prepared For</b> | Bellingen Shire Council |
| <b>Date</b> | 17/06/2022 |

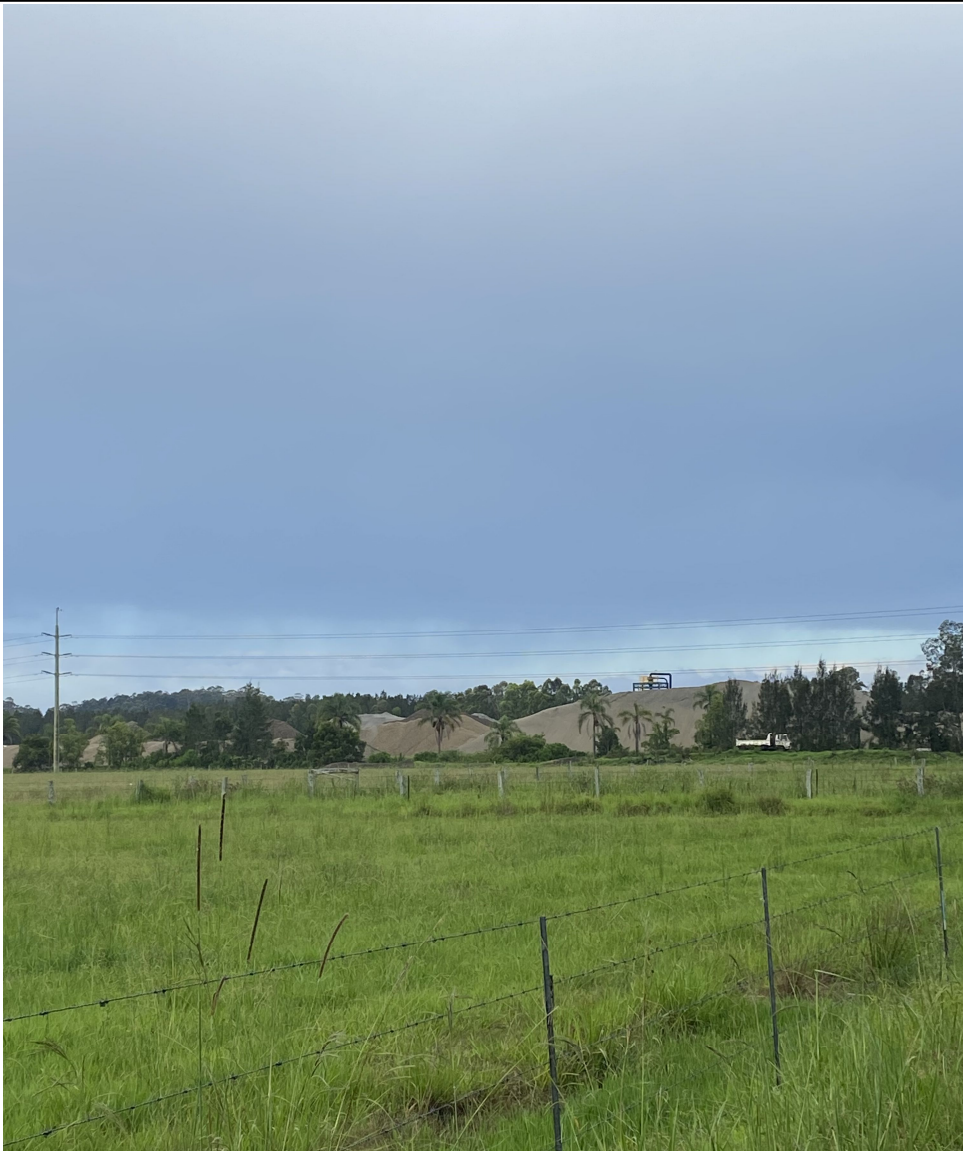
**Figure A-5 Facility at Repton used to Process Sand Extracted from the Bellinger River downstream of the Pacific Highway**

Downstream of the tidal limits, the estuaries are contained within incised valleys for some distance before reaching the broader, low-lying coastal floodplain. The Bellinger River continues for some 15 km downstream to McGearys Island, where the landscape opens onto the broader coastal floodplain. Unsurprisingly, this is a depositional area, and the site of an ongoing sand extraction operation (Figure A-5).

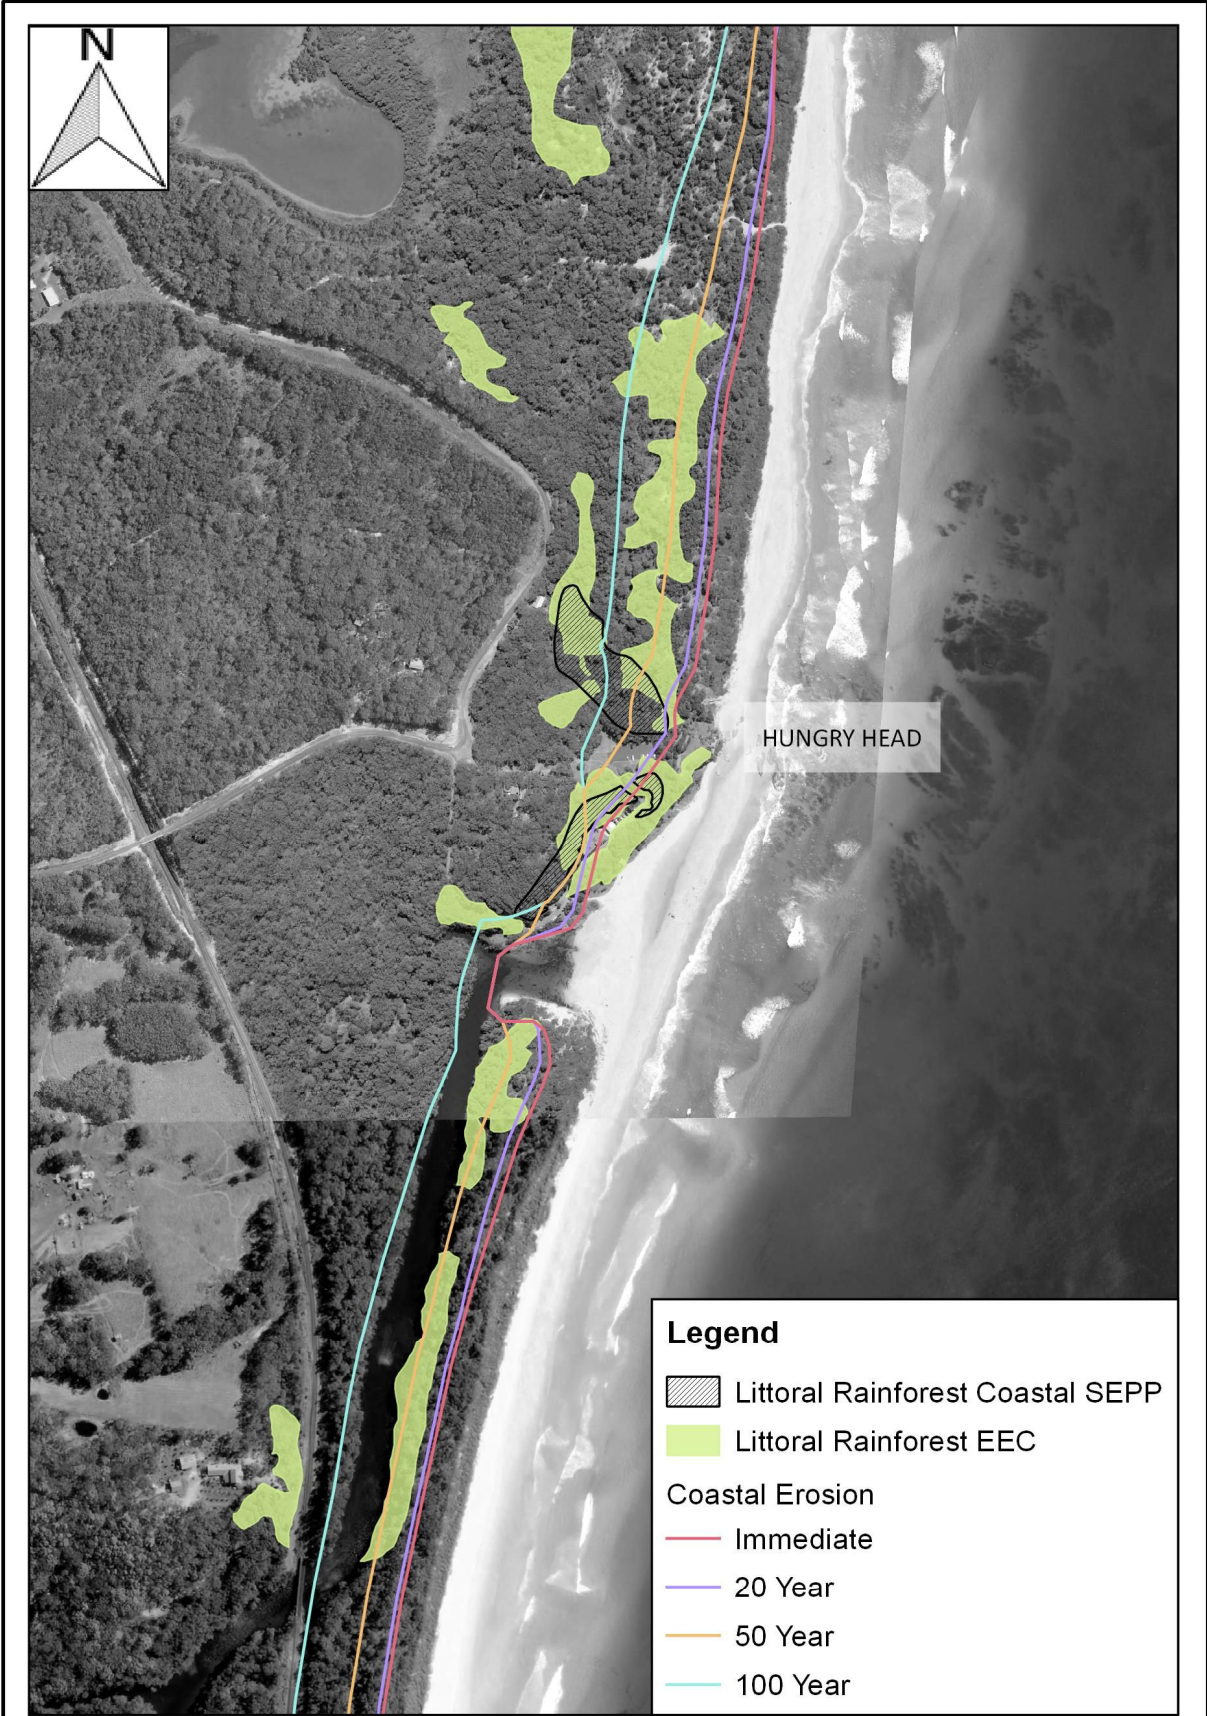
**Figure A-17: Littoral Rainforest and Projected Coastal Erosion at Hungry Head**

It is evident that areas of Littoral Rainforest on North Beach, Hungry Head and Wenonah Head are at immediate risk, with increasing areas of risk over time. The patch of Littoral Rainforest at Valla Beach remains unaffected by projected coastal erosion.

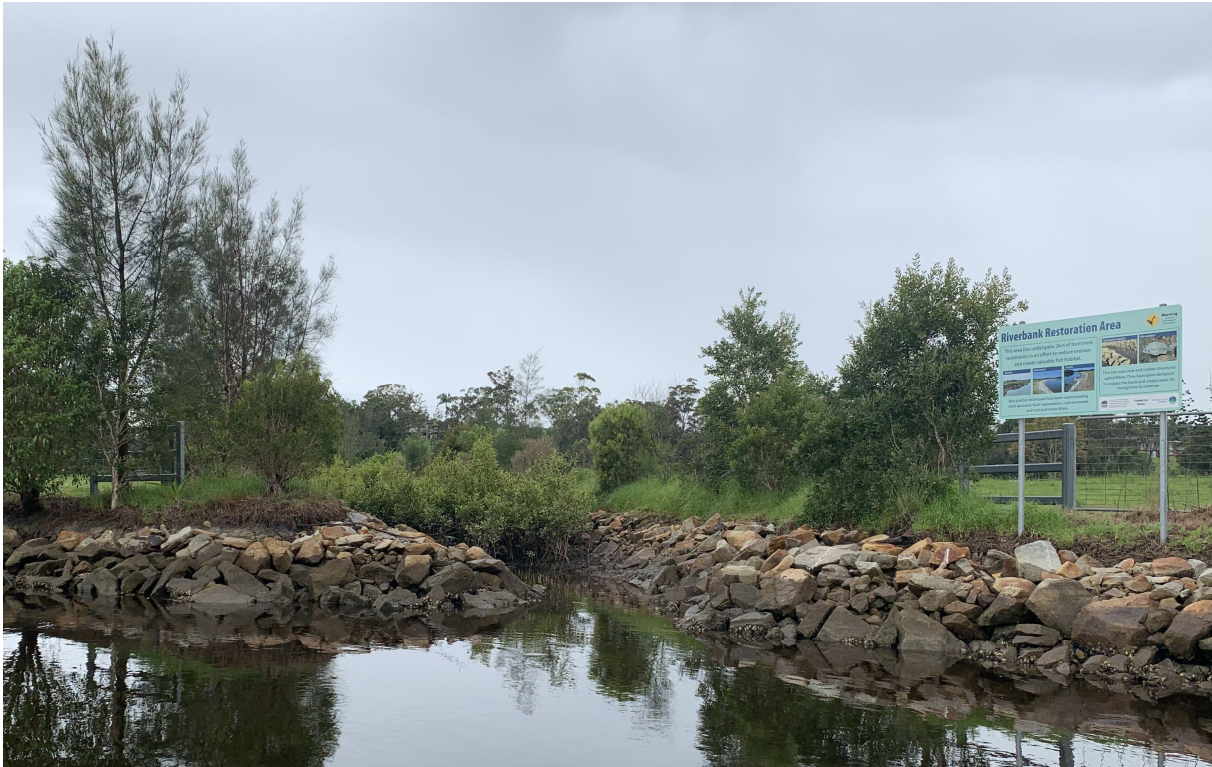
**Figure A-24 Mangrove re-establishment following stabilisation of drainage line, Newry Island**

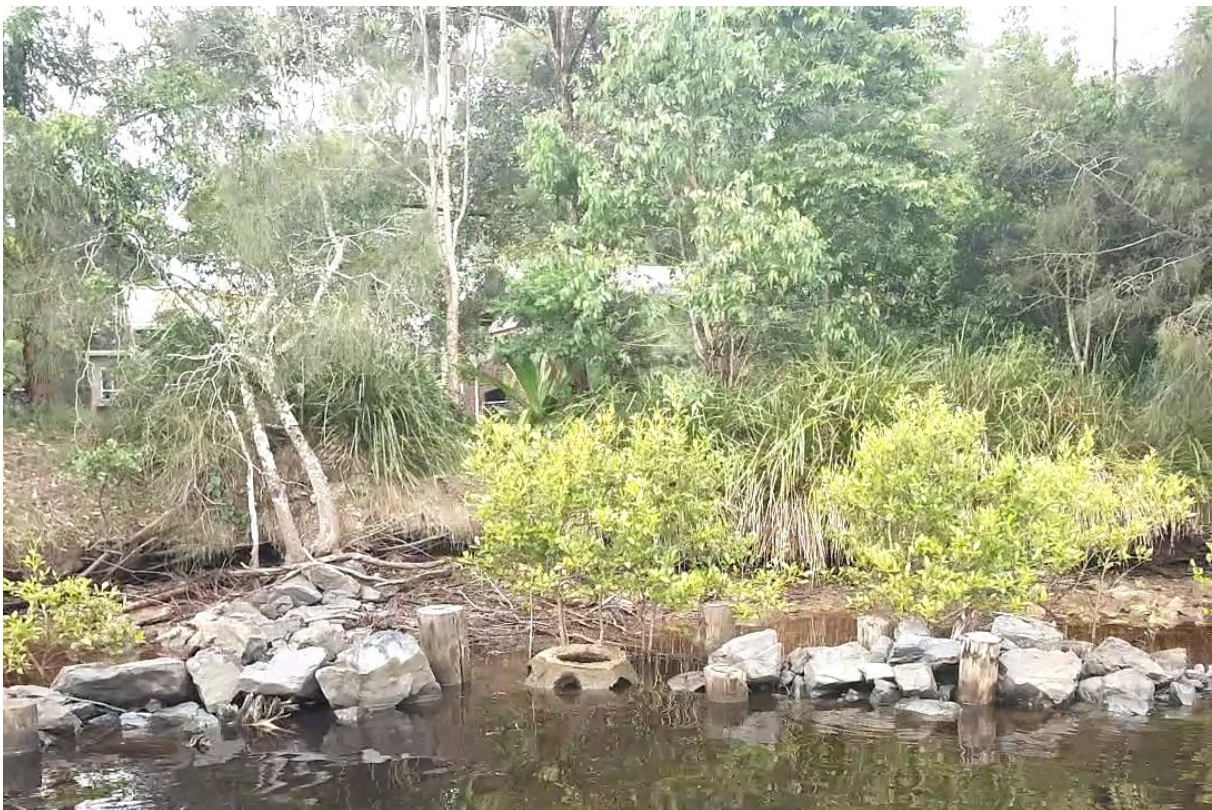
**Figure A-25 Mangrove re-establishment behind rock fillets, Newry Island**

Figure A-25). Beyond the ecological benefit, the mangroves also provide bank protection through wave and flow attenuation.
