# Fact sheet | Urunga Wetlands

The Urunga Wetlands site is now a valuable community space following a \$10 million program of extensive remediation and parkland work. It has been transformed from a once barren wasteland to a lively wetland habitat.

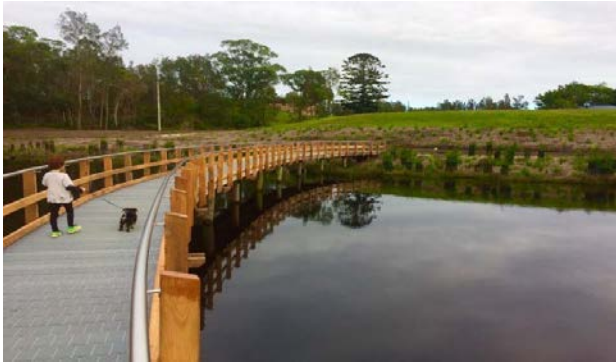
**Timber boardwalk over Urunga Wetlands**

A great destination for locals and visitors to the region, the site has a 150 metre boardwalk allowing people to walk over the wetland and a 450 metre walking track surrounding the park.

The validation for public open space was successful and allowed the site to be developed into parkland with infrastructure that includes a 450 metre sealed footpath and 150 metre boardwalk out over the wetland.

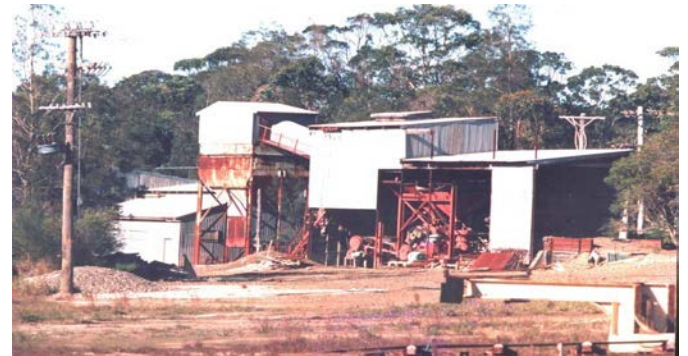
**The old antimony processing plant (circa 1980)**

The processing plant was used for extracting heavy metal antimony from its ore, stibnite.

After the ore was delivered to the site, it was crushed and the antimony removed using complex chemical reagents and equipment.

The antimony processing plant employed local people to operate the machinery and bag the product but in 1974 the plant was abandoned.

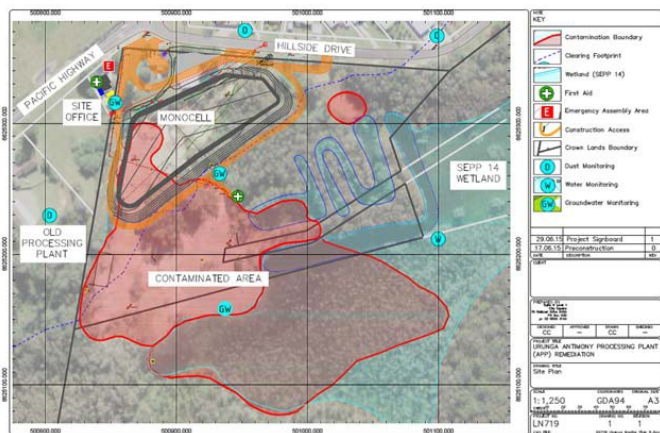
Site plan showing the contaminated area

A two year investigation was undertaken with the assistance of GHD Pty Ltd. The investigation was required to understand the type of contamination affecting the site so that the best remediation options could be developed.

The recommended option approved by the Environmental Protection Authority involved excavating the site, treating the contaminated material and then placing it in a specially engineered containment cell that was to be covered and revegetated.

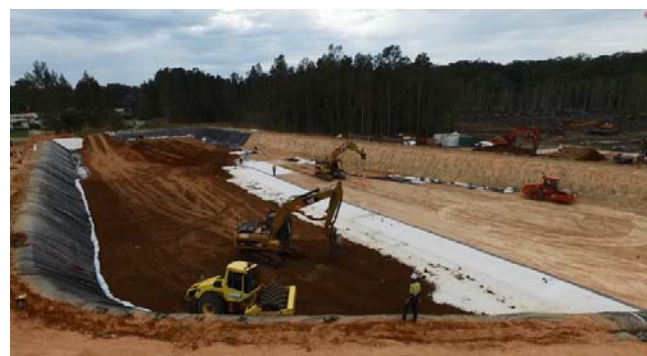
The base of the containment cell during construction (2016)

Only a grassy mound now indicates where the containment cell is located, but beneath that surface is an engineered structure with 15 different layers.

The containment cell was designed for a 100 year life. It functions by separating the treated waste from all water streams, including surface waters and groundwater.

The structure is fitted with a leachate collection layer. It has an access pipe to facilitate monitoring and sampling and also allows for leachate removal if required.

This material was stockpiled and then treated with chemicals to stabilise the waste before disposing of it in an engineered containment cell constructed on-site.

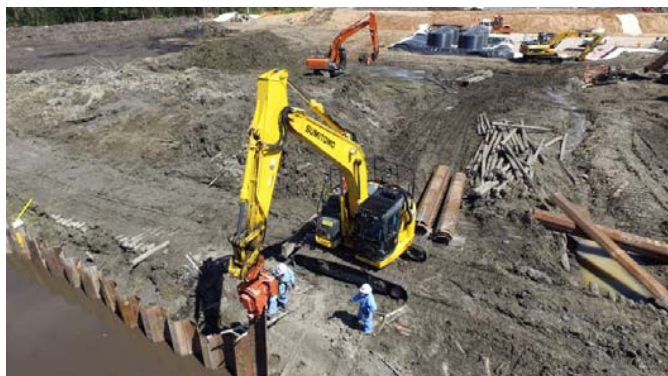
**Installing a sheet pile wall to hold back the wetland water**

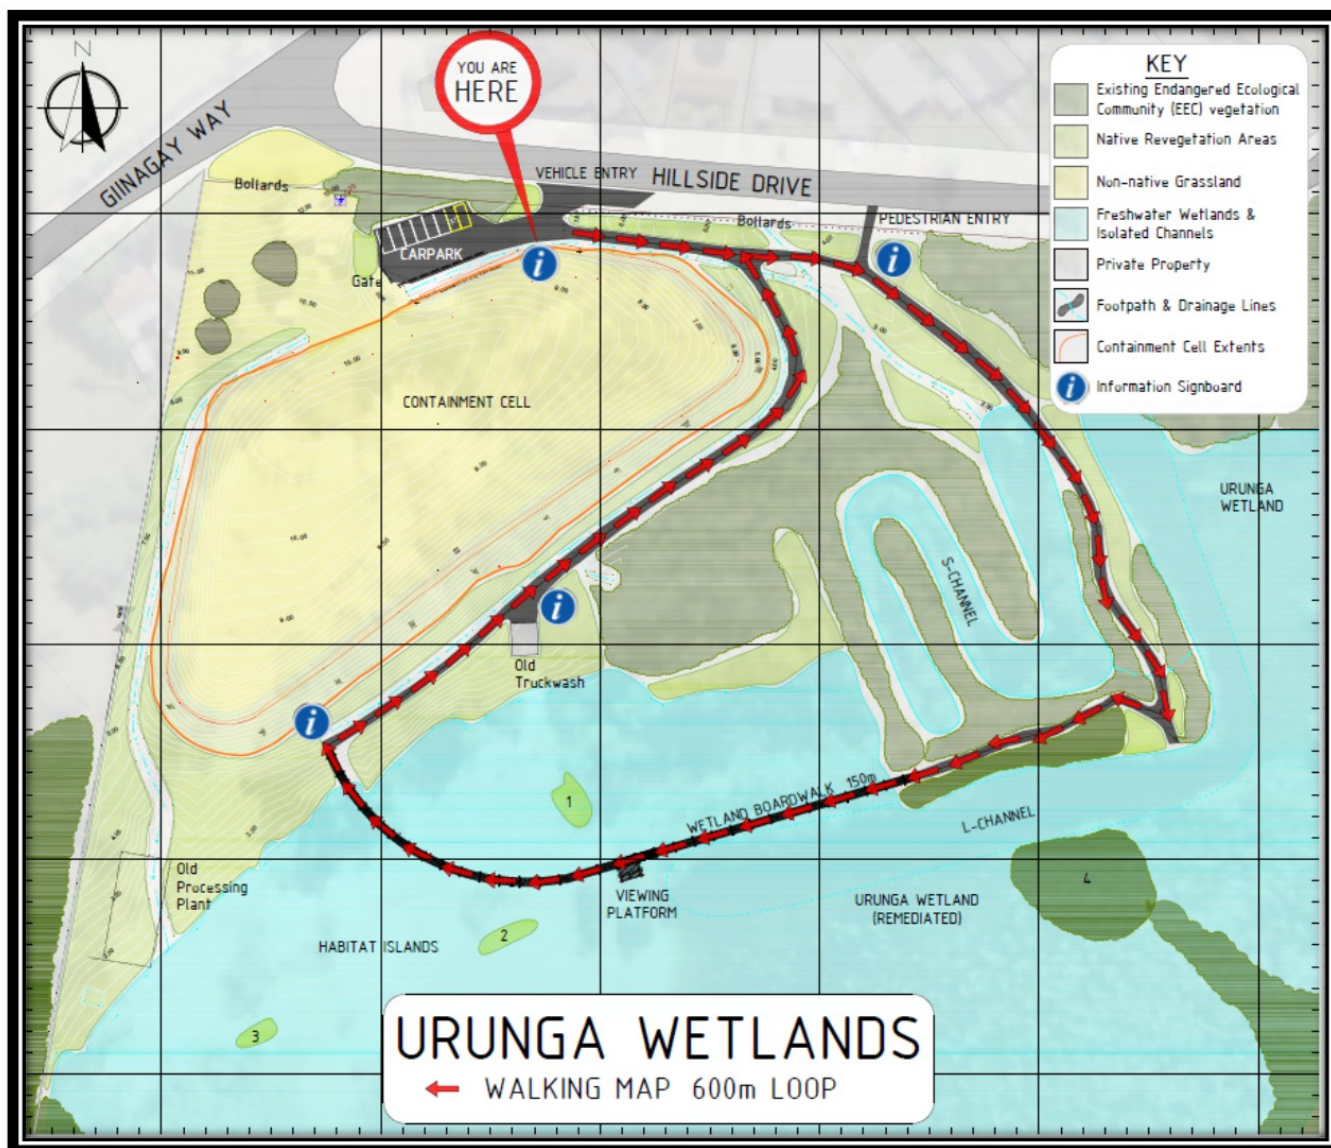
**Walking trail around Urunga Wetlands**

The walking trail around Urunga Wetlands takes you in a 600 metre circuit from the carpark, down to the water's edge and across the boardwalk back up past the containment cell, which looks like a grassy mound.
