# Managing River Oaks and other in-stream vegetation in Gravel-bed Rivers on the NSW Coast

This fact sheet provides land managers with an understanding of the role of in-stream vegetation in the dynamics of the river channel, as well as tips and techniques for managing vegetation that grows in rivers with gravel beds.

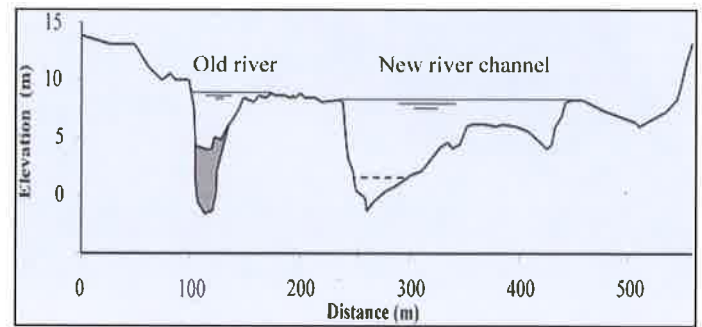
Above: **Bellingen River channel size at Bellingen Island**  
*The old river channel was narrow and deep, the new channel is shallower and broader.*

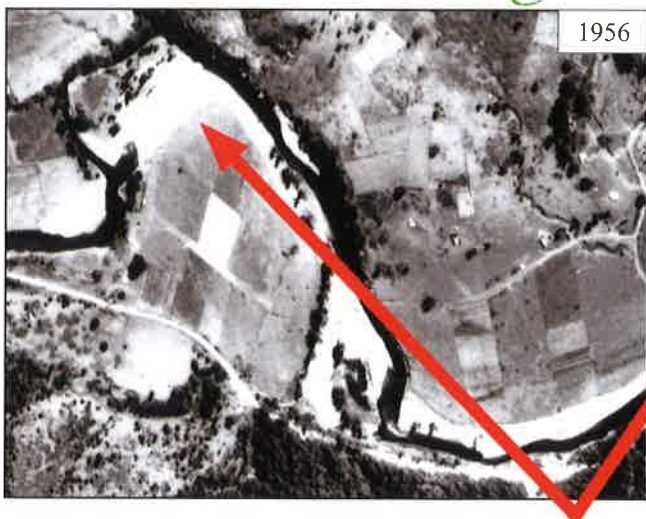
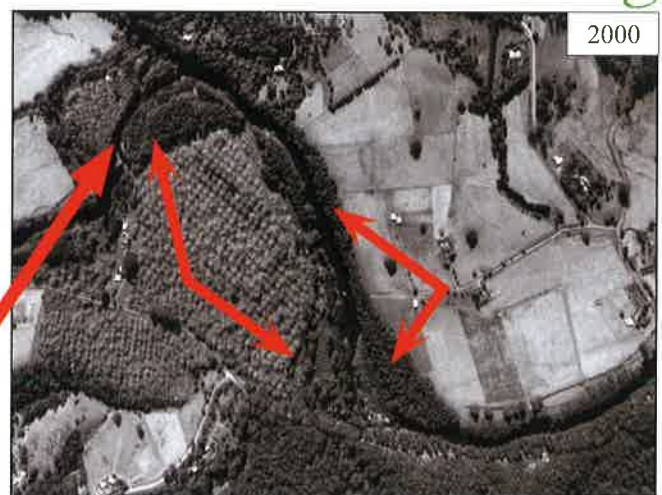
## Historical channel changes on the lower Bellingen River at Gordonville cutting

Note the presence of the bare gravel bars and shortcutting at the top left hand side of the photos, as a result of the 1950 flood, followed by progressive colonisation of river oaks (see picture on right).

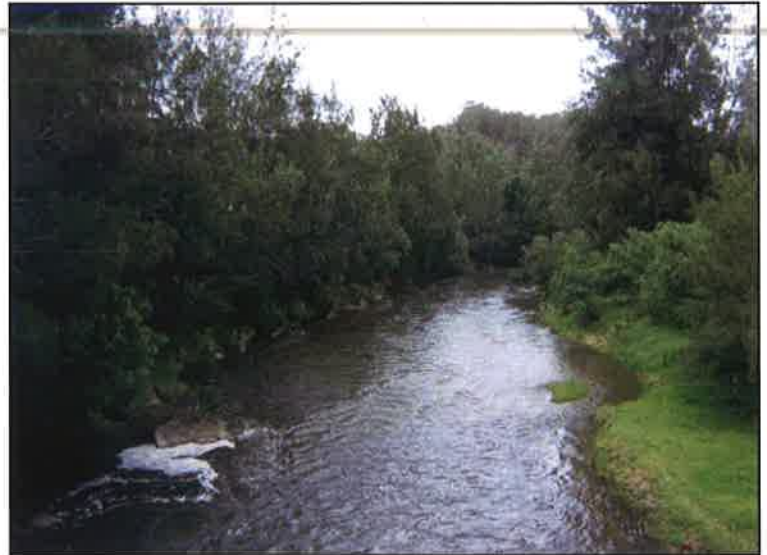
**1996:** Over-wide channel with island beginning to form (*on right*)

This sequence of photos shows how the river oaks have helped to stabilise an in-stream island and narrowed the river channel.

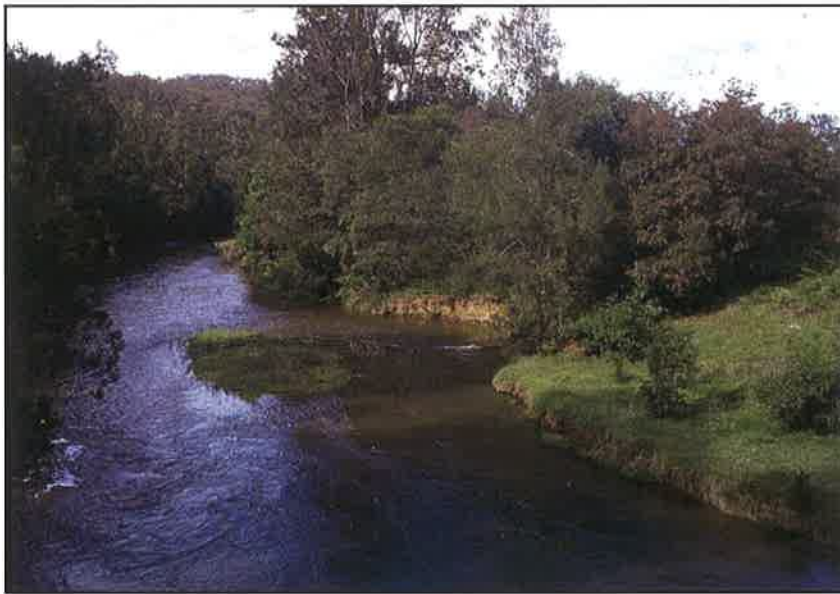
**1999:** Island is larger and bank erosion more severe (*centre of photo*)  
Deposition of gravel continues, the island grows, a riffle develops up stream of the island.

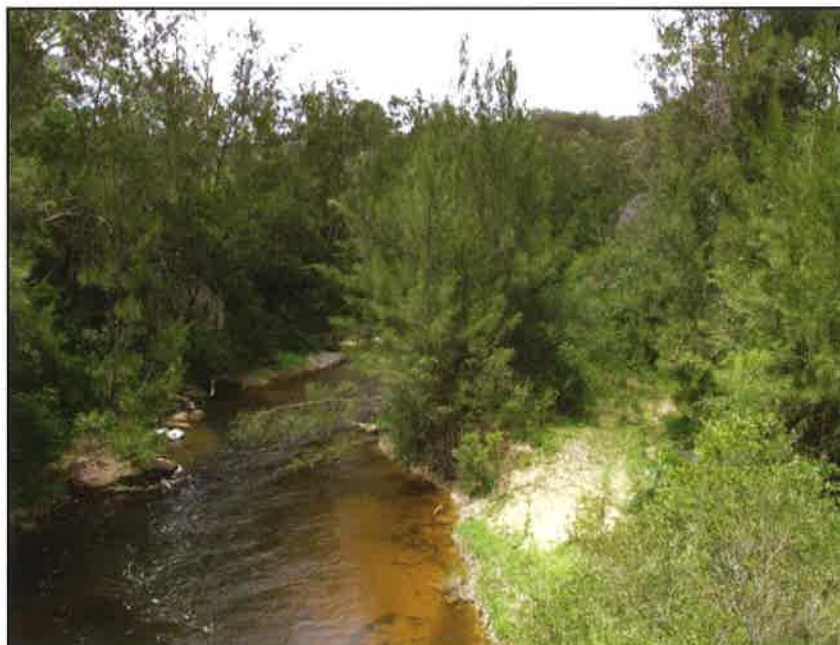
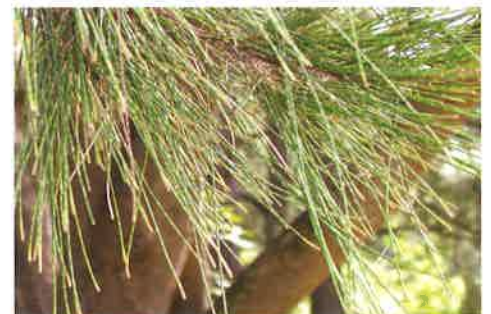
**2005:** Livestock has been excluded and river oaks established on the island.  
Deposited gravel has closed the gap to the eroding bank. The up-stream riffle has fully formed and a pool developed downstream.

*Photos taken at Blaxlands Creek, Nymboida catchment*

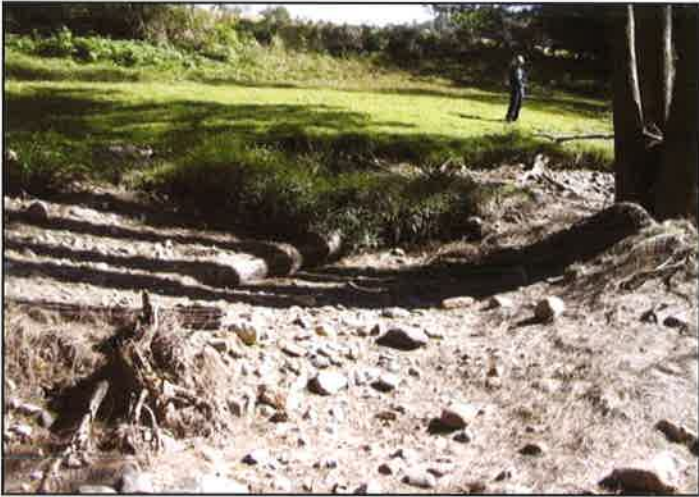
## Issue 1: Scouring holes behind large individual river oaks.

Water flow forms eddies behind the stems of large trees and scours holes into the gravel bed.

Planting a greater density of trees and understorey plants (e.g. lomandra) around the trees will dissipate the flow and reduce scouring.

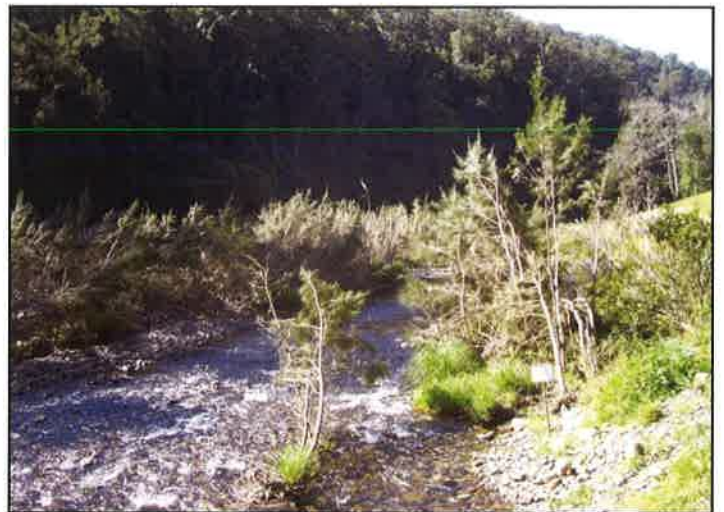
## Issue 2: River oaks on gravel island narrow the channel and divert flow towards weak and unprotected bank.

Increase overall bank strength through structural rehabilitation works and revegetation.

Cut or thin River Oaks to allow high flow over the gravel bed.

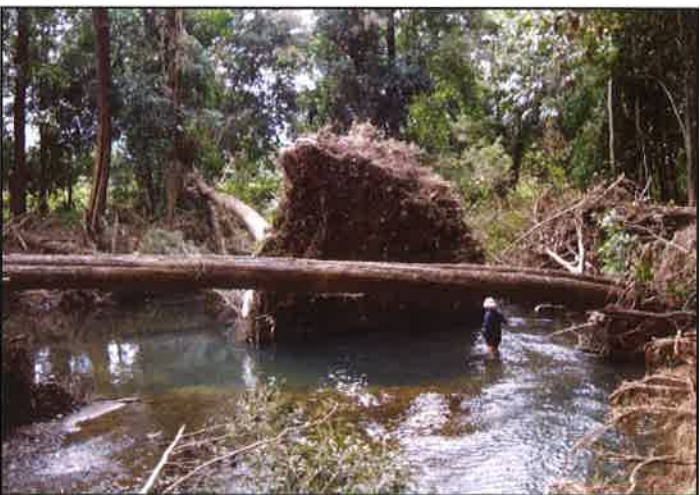
## Issue 3: Mature river oak fallen into the river bed and threatening to deflect flows into river bank.

Pull trunk and rootball in against the bank with the rootball facing upstream and oriented away from the bank towards the channel. Depending on the size of the tree it may need to be anchored in place.

Increase overall bank strength by planting a wider vegetated zone on top of the bank.
